Why are Atalaya's Riotinto tailings dams at risk?

A summary report by Richard Harkinson, outlining the key findings from a risk analysis report by Dr Steve Emerman

Tailings dam risk at Riotinto mine, Andalucia

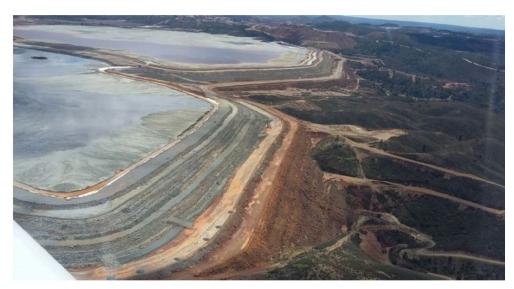
The mine waste is stored in two tailings ponds or reservoirs - these are named Cobre and Aguzadera reservoirs. These two reservoirs are confined by a tailings dam, although they also share a common dam wall. Excess water from the tailings reservoirs is pumped into a third reservoir, the Gossan reservoir, behind a third dam. Since the Cobre reservoir is upstream from the Aguzadera reservoir and the Gossan reservoir is upstream from both tailings reservoirs, the three dams could fail in a chain reaction - like dominoes.

Fig 2: Cobre and Aguzadera mining waste dams. Ecologistas en Accion
