THE RIVER IS DEAD

The impact of
the catastrophic
failure of the
Fundão tailings
dam

OCTOBER 2017

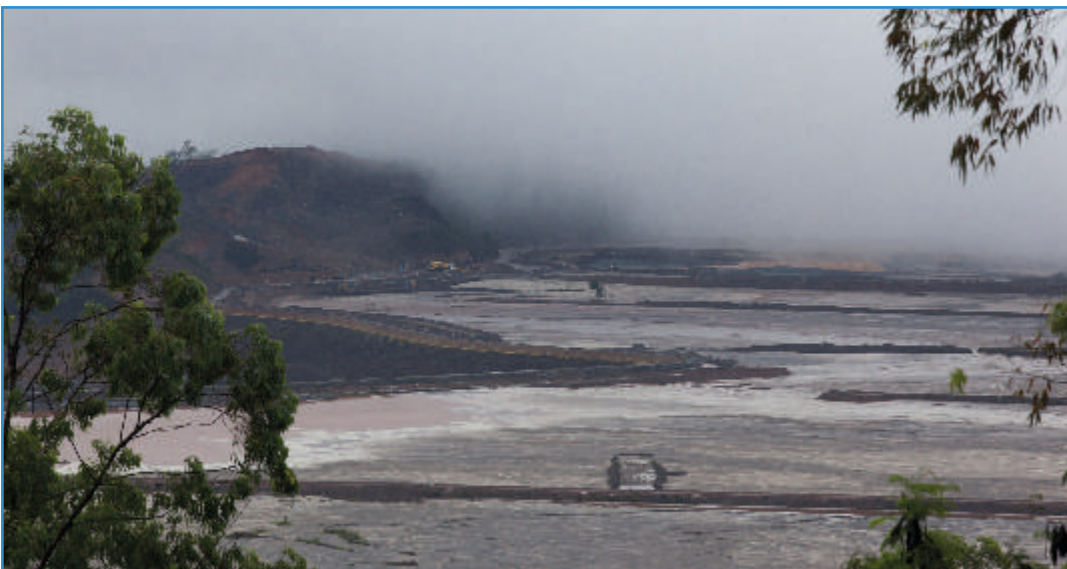
A view over the tailings ponds near the Germano Mine, showing their size and what is behind a tailings dam. (Nilmar Lage)

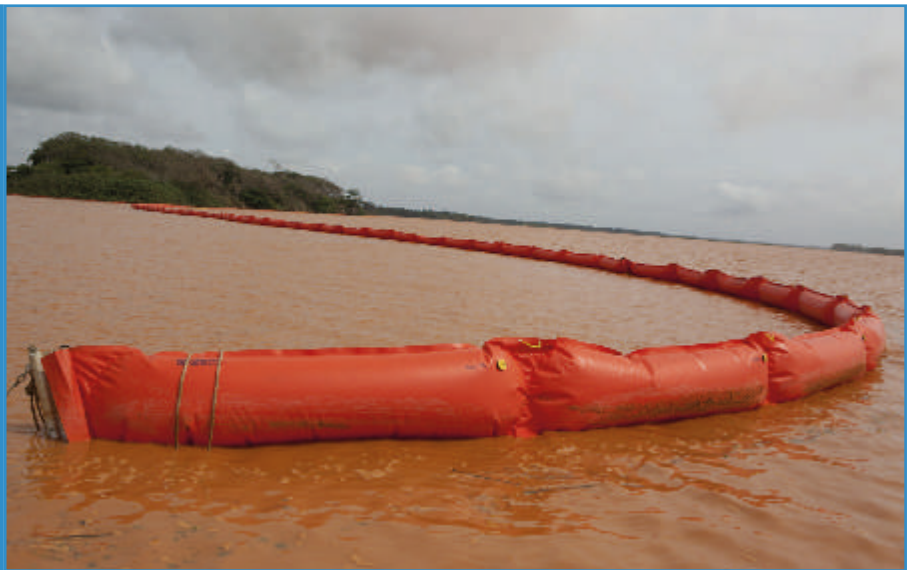
Floating booms were deployed as the pollution approached the mouth of the Rio Doce, in an attempt to prevent water polluted by mining waste spreading into creeks and some parts of the shoreline. This failed because the waste was in suspension and passed under the booms. The booms are designed to prevent the spread of surface oil pollution, not pollution in suspension. (Nilmar Lage)

SAMARCO deployed floating booms in an attempt to prevent mining waste entering into the side channels of the river in the delta, but this failed as the booms were designed to prevent flows of surface pollution, such as oil, and not sediment in suspension. Contaminated water flowed under the booms and into the side channels and some low-lying areas such as Entre Rios (where farmers build their houses on stilts in case of floods). Fields were thus covered by a thin layer of sediment, and local people believe that the mining waste has infiltrated the sub-surface water.

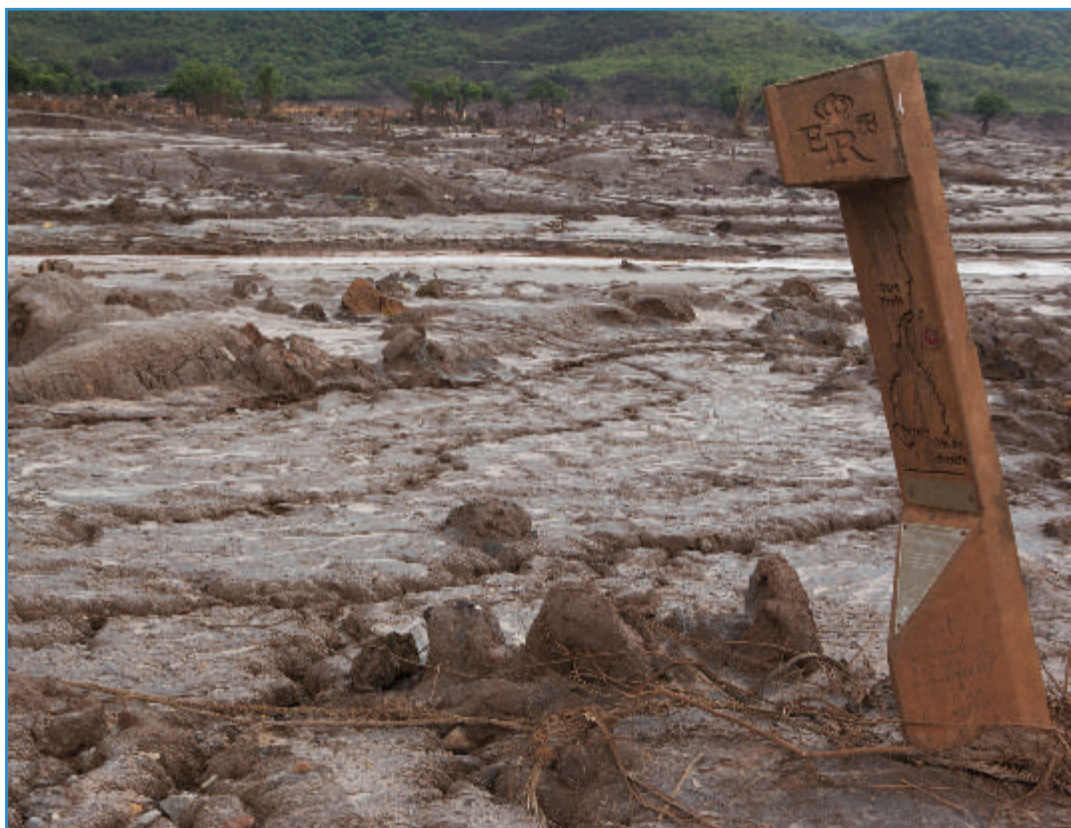
The historic Estrada Real (the Royal Road built by the Portuguese crown in the early 18th century) passes through Bento Rodrigues. One of the marks of the Estrada Real is surrounded by the devastation one month after the dam collapse.

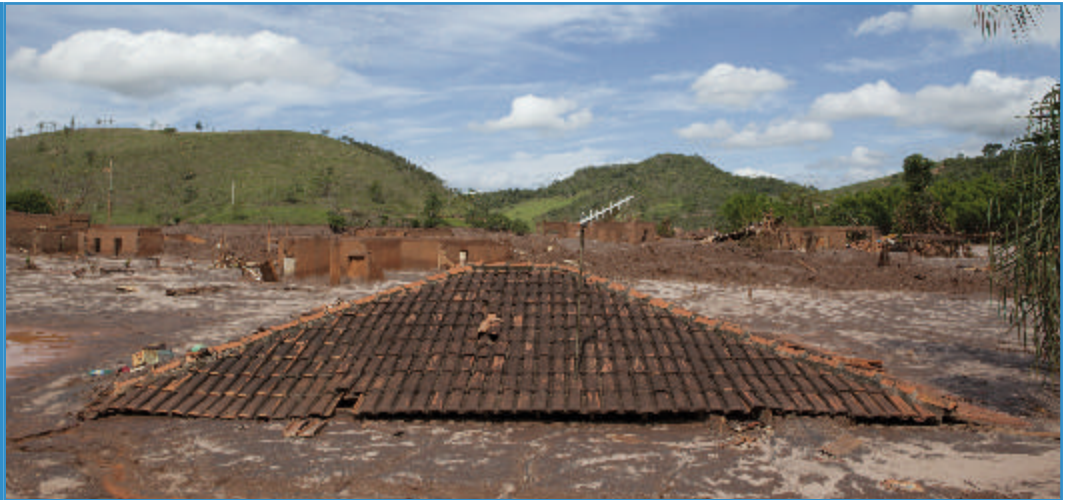
A month after the collapse of the Fundao Dam, just the roof of a house is showing above the mud in Paracatu de Baixo. (Nilmar Lage)

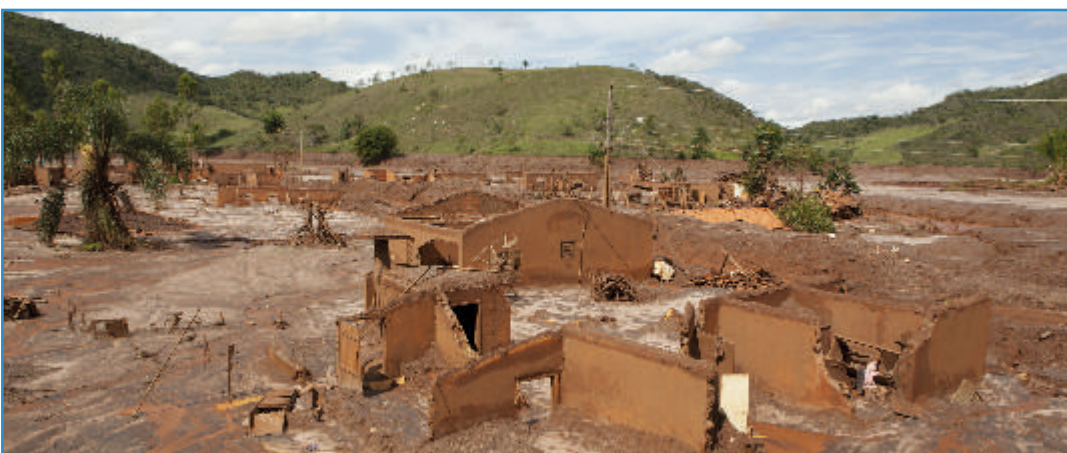
A month after the collapse of the Fundao Dam Paracatu de Baixo is a scene of devastation. (Nilmar Lage)

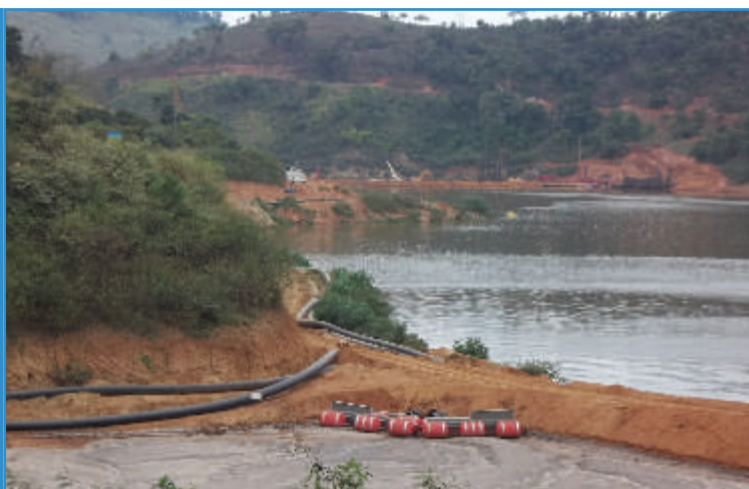
The Candonga Dam (a hydro-electric dam) trapped about 10 million cubic metres of the flow of mining waste (though possibly 20 million cubic metres of the finer sediments went over the dam and polluted the lower reaches of the Rio Doce). The reservoir of the Candonga Dam thus contains large amounts of the coarser sediments. SAMARCO (and then RENOVA) have been carrying out (since late 2015) a lot of work to try to remove some of this waste from the reservoir and to put in various forms of sediment traps. There is a lack of suitable places to deposit waste removed from the reservoir. Structures are being built to retain sediment in the side arms of the reservoir or to retain waste pumped out of the reservoir. (Paul Robson)

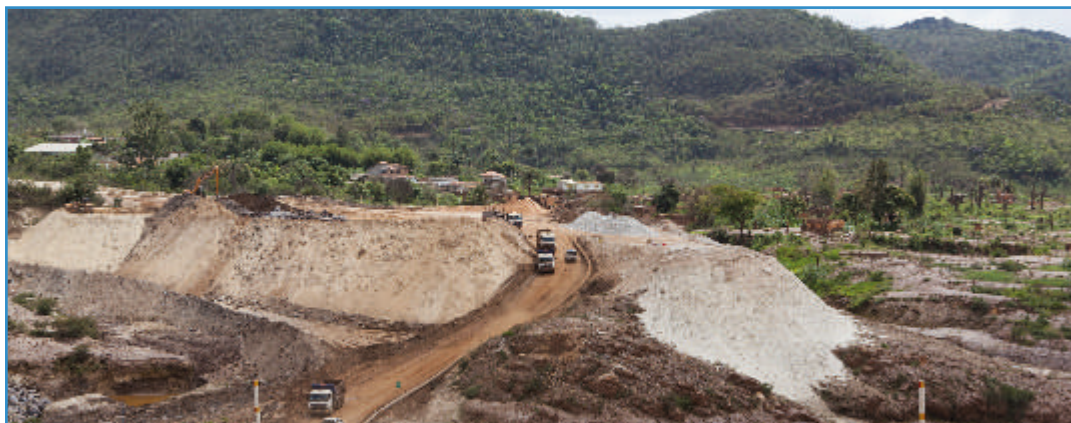
Construction of dam S3 at the settlement of Bento Rodrigues. S3 is a sediment weir, an attempt to reduce the amount of sediment entering the river system from the area of the mine and the collapsed tailings dam. (Nilmar Lage)

water-courses. Sediment weirs S3 and S4 have been constructed on the Corrego Santarém above and below the settlement of Bento Rodrigues. These are to reduce the amount of mining waste flowing downstream by acting as sediment traps. They have raised the river level so the agricultural lands of Bento Rodrigues are under water, and this makes it difficult for the former residents of Bento Rodrigues to imagine that they will be able ever again to have access to their lands. The construction of these weirs was opposed by the residents of Bento Rodrigues as they say that it was not discussed with them, they received no compensation, and they fear losing their property rights.

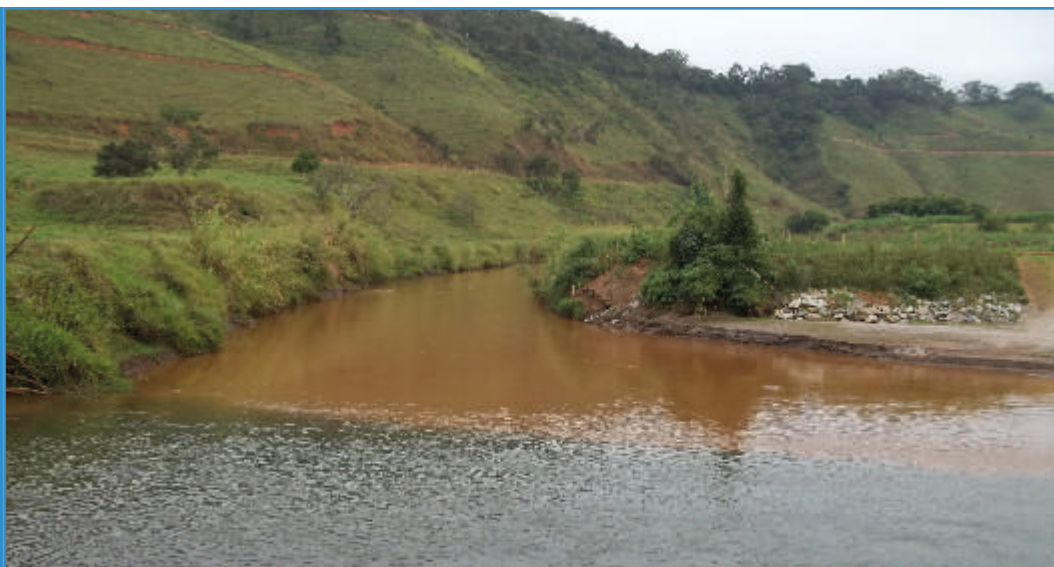
The confluence of the Rio Carmo and Rio Gualaxo do Norte on the outskirts of the settlement of Barra Longa. The water of the Rio Carmo, flowing from the left, is clear while the water from the Rio Gualaxo do Norte, flowing towards the camera, is brown with the mining waste it is carrying from the region of Fundão Dam more than 18 months after the collapse of the dam.
(Paul Robson)

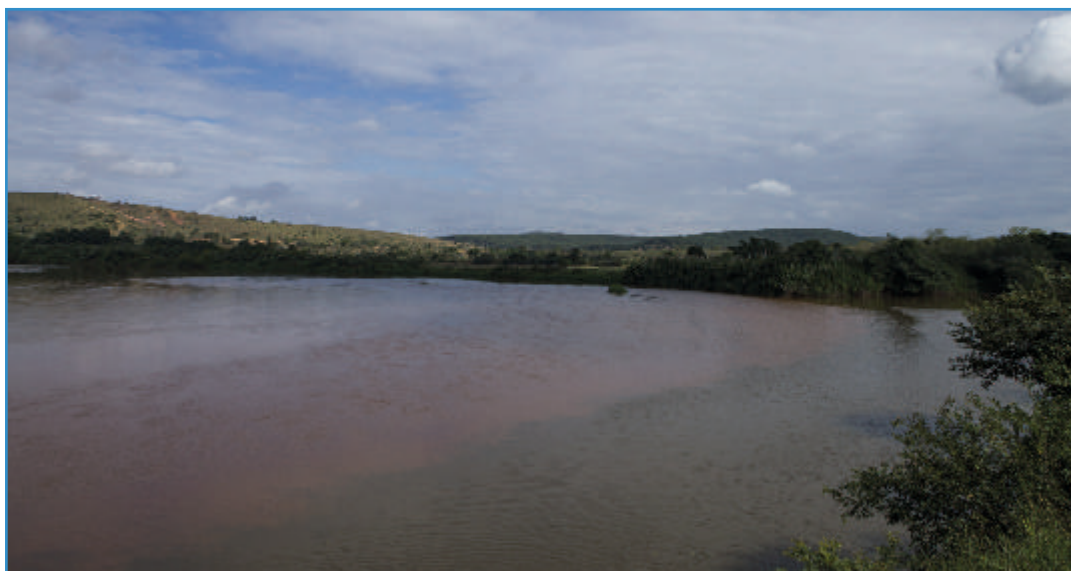
The confluence of the Rio Doce and the Rio St Antonio at Naque. More than 18 months after the collapse of the Fundão Dam, the Rio Doce is still brown and contrasts with the clear water of the Rio St Antonio (coming in from the right). (Nilmar Lage)

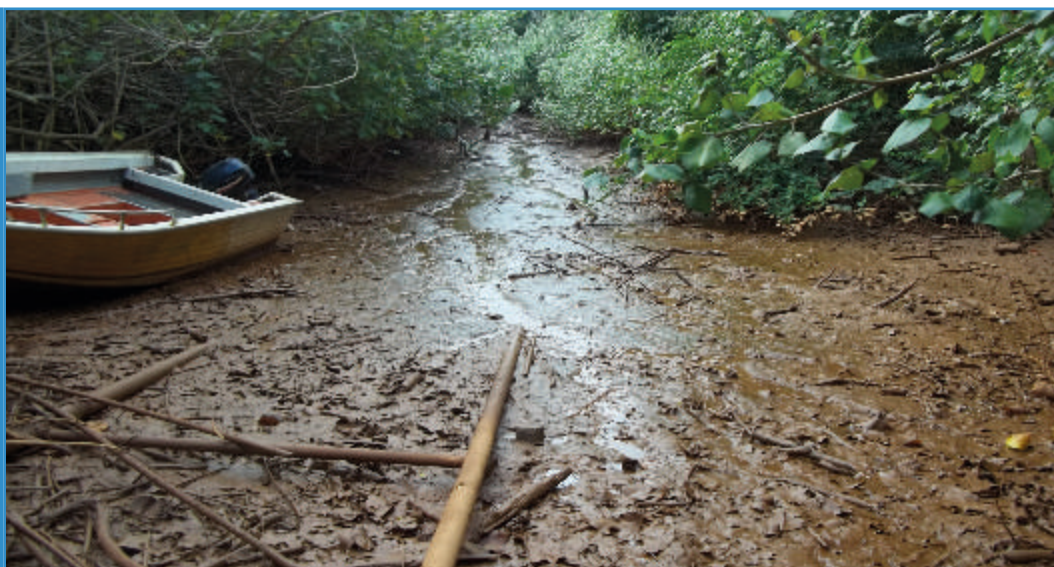
A creek with mining waste sediment in the delta of the Rio Doce near Regência

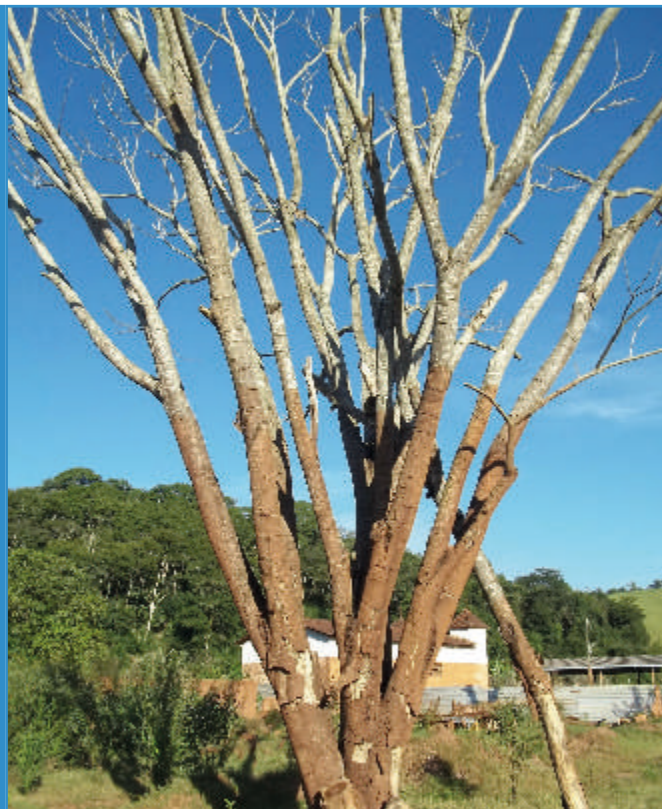
Paracatu de Baixo is a settlement largely destroyed by the flow of mining waste. The tree was killed by the flow of waste, and the brown mark shows the height of the flow of mining waste.

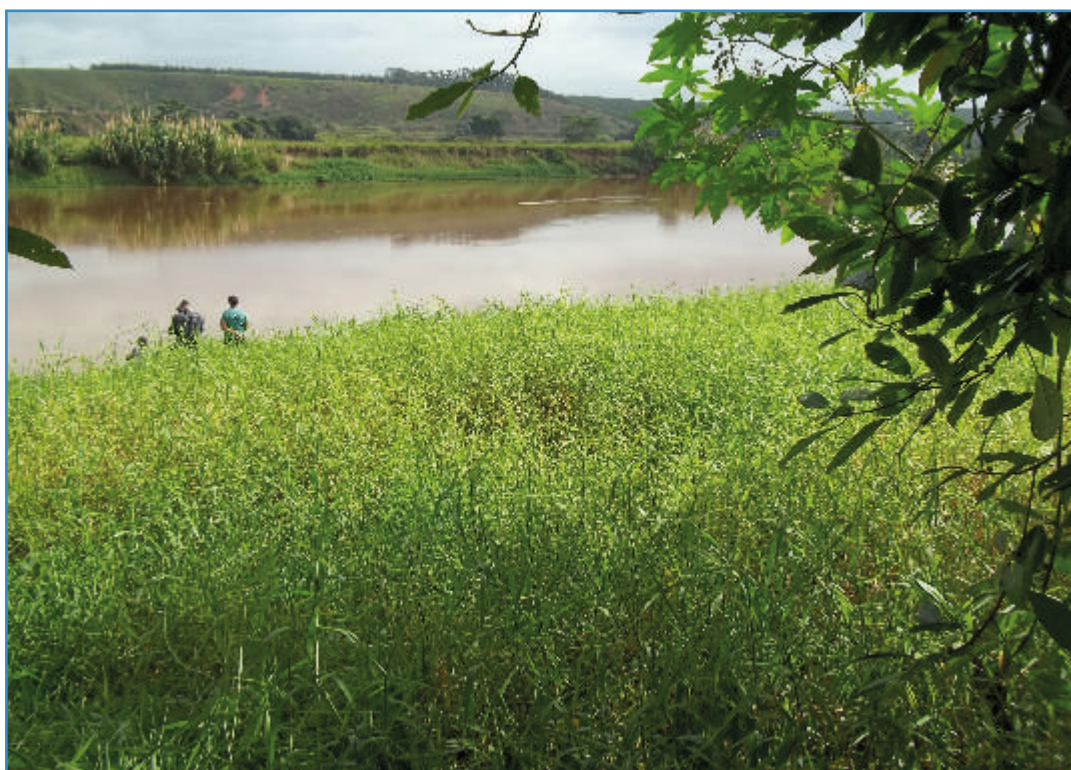
Former vegetable gardens near Ipaba, below the Candonga Dam. Part of the river bank was covered by mining waste in this area, though there is little mention of this in official reports. Small-scale farmers have given up cultivating the river banks, but have difficulty in being recognised as affected by the dam collapse as they are not registered businesses and do not have receipts for sales of vegetables.

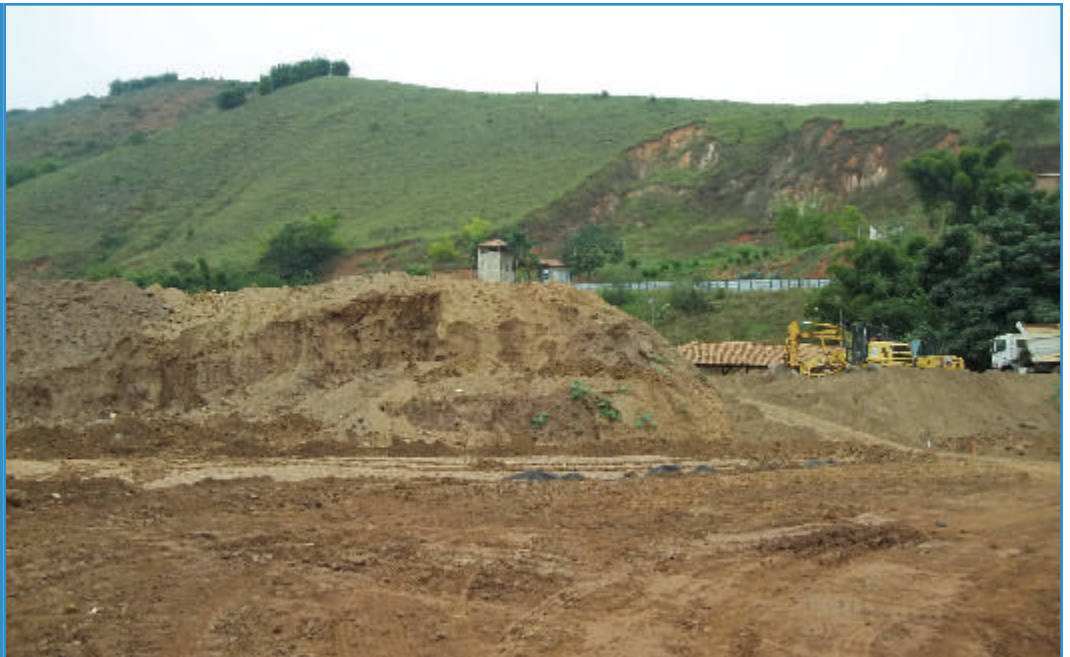
Barra Longa - a small town above the Candonga Dam, where the waste flow flooded part of the centre of the town - the waste was removed from the centre of the town and dumped on the outskirts near a poorer part of town
